# NEBRASKA GROUT TASK FORCE

## In-Situ Study of Grout Materials 2001-2006 and 2007 Dye Tests

Educational Circular EC-20  
Conservation and Survey Division, School of Natural Resources  
Institute of Agriculture and Natural Resources  
University of Nebraska–Lincoln

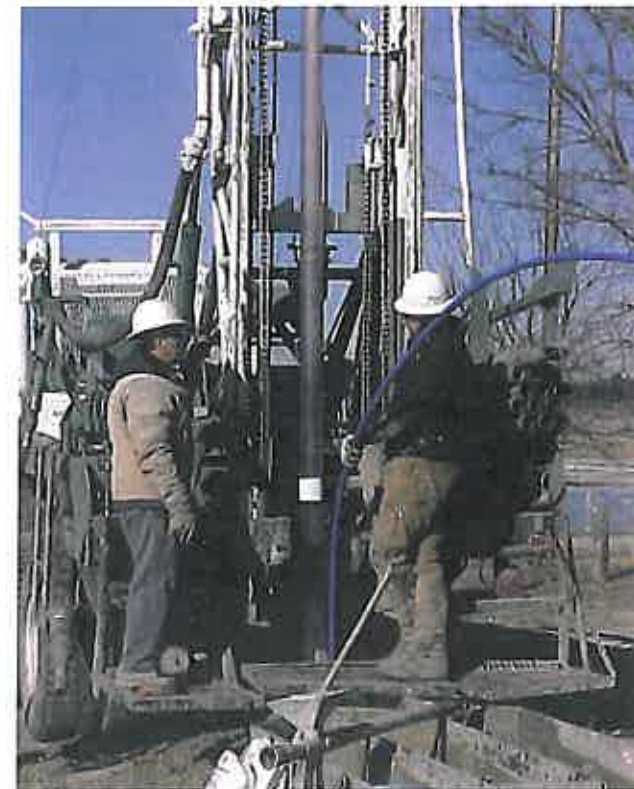
Figure 3. Installation of clear PVC casing with tremie pipe.

For all installations except heat loops, the 4.5-inch outside diameter (OD) Schedule 40 clear casing and slotted screen were installed in the boreholes at the target depths (Fig. 3). Centralizers were set every 20 feet. Gravel pack was poured or tremied into the annulus from the bottom of the borehole to about 2 feet above the top of the screen. The top of the filter pack was tagged with a weighted tape to ensure proper placement. A 2- to 3 feet, 3/8 inch chip bentonite seal was placed above the filter pack. Then the specified grout was placed above the seal according to NGTF's specifications.

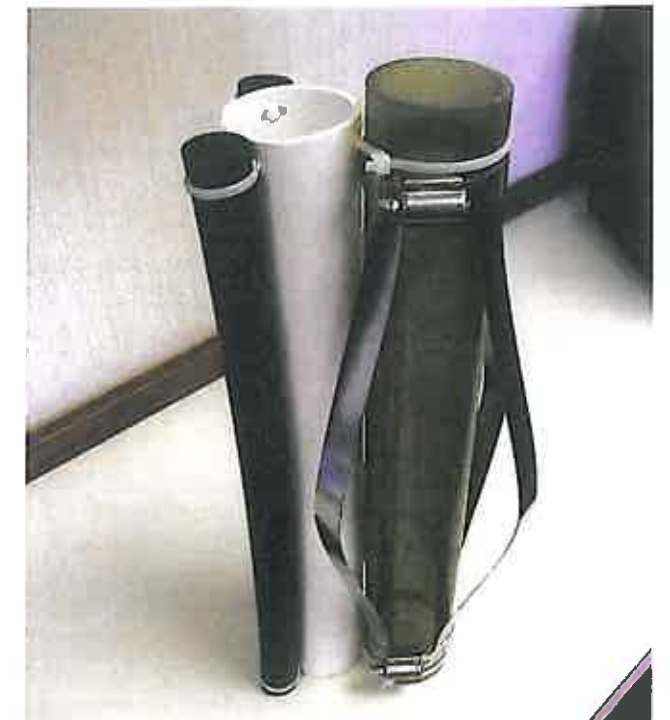
Figure 10. Example of geothermal loop installation.

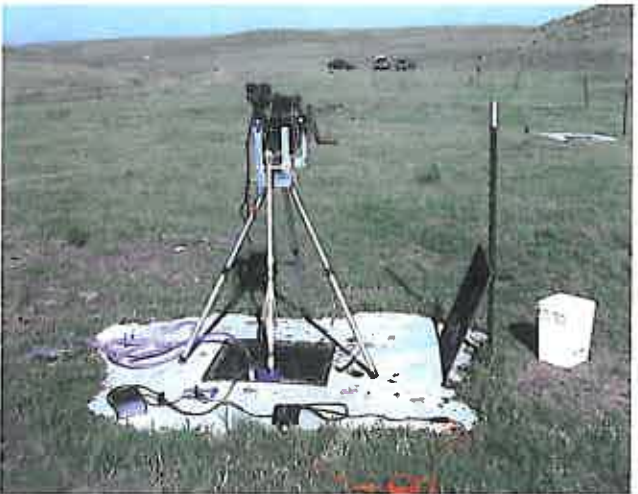
Figure 13. Down-hole camera survey equipment.

NDHHS/Water Well Standards Program supplied the down-hole video camera (Fig. 13). Down-hole video equipment was disinfected prior to it being used in the well. Key information noted on a clipboard was videoed prior to each camera survey. Original recordings were in Digital 8 format. New camera equipment allowed for recordings in VHS format that were transferred to DVD's.

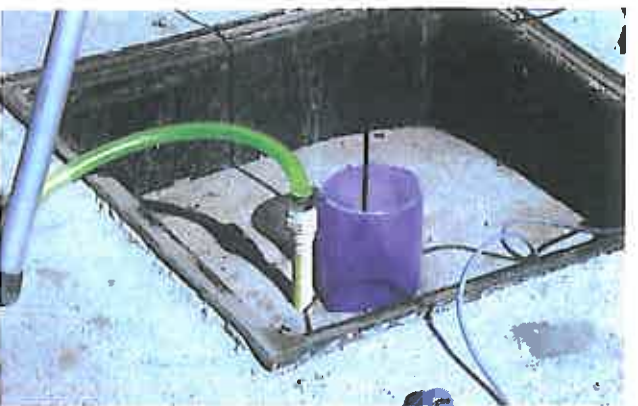
Figure 14. Dye testing.

The NGTF Technical Team adapted the dye test techniques used by the Ohio Department of Health (May 2000). Surface completion diagrams (Figs. 11 and 12) show the configuration of the dye reservoirs. The dye was non-toxic food grade quality. In dye tests performed between 2004 and 2006, we used a yellow-green fluorescein dye. NDHHS personnel swabbed the dye tubes to eliminate the possibility of any obstructions in the tube that could alter the results of the dye test. Then a clear hose was attached to the dye tube and connected it to the 220-gallon dye tank (Fig. 14).

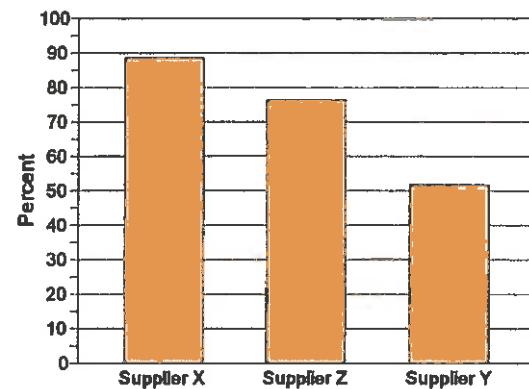
Figure 21. Percentage of the unsaturated zone penetrated by dye.

We calculated the percentage of the unsaturated zone that the dye penetrated for each well in order to compare grout performance between sites. The water level recorded at the time of the dye test was used for calculations at the Grand Island and Trenton sites, which resulted in site averages of 63% and 92%, respectively. For the Pilger site the water level in the shallow aquifer was used to calculate this percentage because the water table conditions would impact all the grout installations. The average percentage of the unsaturated zone penetrated by dye at this site was 81%.

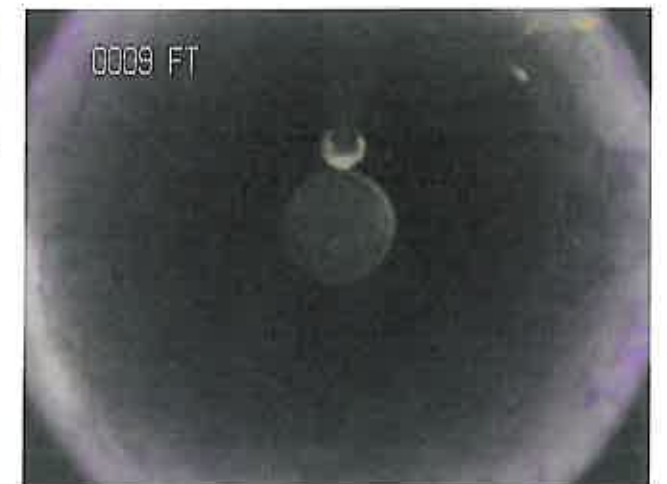
Figure 26. Grand Island bentonite chip grout.

The results of the visual assessment of the chip well videos revealed few overall inconsistencies in all three wells. The grout seal at Pilger appeared well hydrated with a smooth texture. At the Trenton site the well seal also appeared to be in good condition overall with the exception of several small voided areas. The chip seal at this site did not appear to be as well hydrated as the seal at the Pilger site. It often appeared chunky or coarse in appearance above 27 feet. The grout column at the Grand Island site also appeared to exhibit a somewhat less hydrated appearance in some areas (Fig. 26).

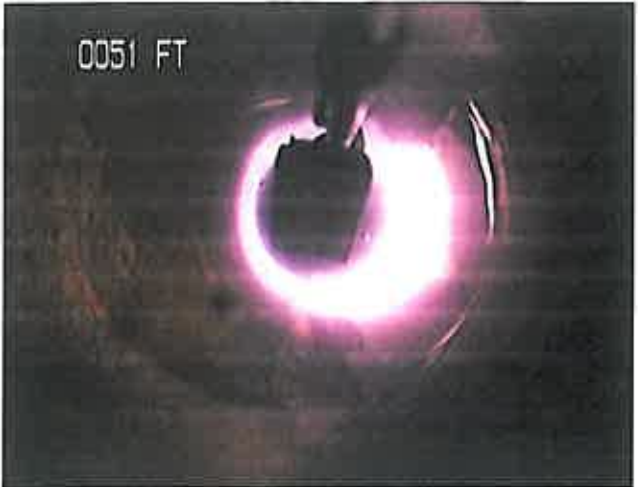
Figure 27. Geothermal grout containing 20 percent solids.

The geothermal bentonite grouts exhibited predominate cracking and voided areas throughout much of the unsaturated zone, as shown in Figure 27. In general, many of the grout seal conditions

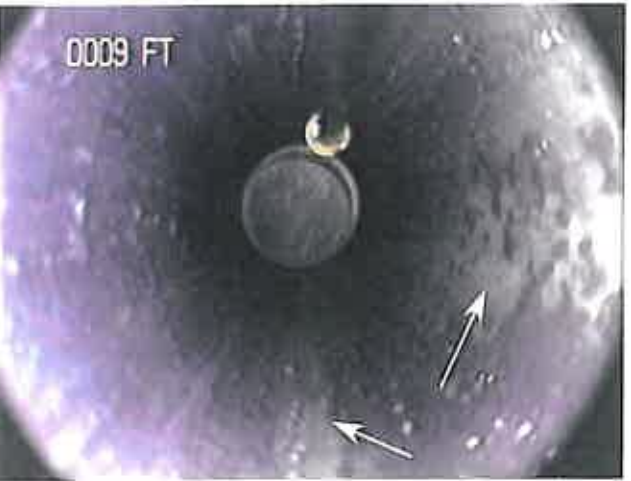
Figure 30. Neat cement appears detached from casing.

Overall the cement wells appeared to show some inconsistencies through most of the unsaturated zone. However, it was difficult to consistently rate the occurrence of these due to the obstacles noted in Section 1 of Chapter 3. The detachment of the grout from the casing was one of the most difficult challenges to assess visually in the cement wells. Detachment may have occurred in many of the wells assessed with this grout type, but may not have been accounted for completely in all of the visual assessments. Figures 28 through 30 show examples of the nature of cement-based grouts.
